Kirkan Wind Farm Limited

Kirkan Wind Farm: Peat Slide Risk Assessment

Technical Appendix 9.1

650395-P9.1 (02)

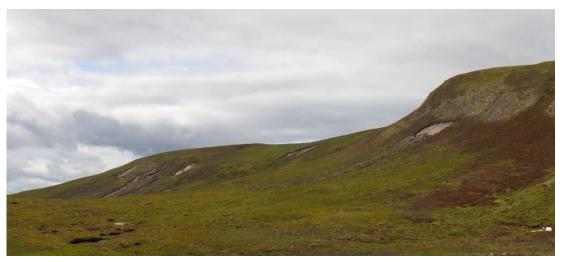
Figure 9.1.1: Landslips on Beinn nan Cabag. View south-south-west from T04.

2.4 There is no notable peat development on the slope, with visible soils of approximately 0.2-0.3 m thickness. The failure surface appeared in all cases to be within the mineral

soil below the organic soil cover. As the landslips are on ground outwith the Strathvaich Estate boundary, closer access to the slips was not possible.
